The Power of Rocks

Ecohydrology Improvements for Scaled Quail Habitat Restoration

Article by **AARON A. ORTEGA-GONZALEZ, JUSTIN T. FRENCH, CARLOS E. GONZALEZ** and **LOUIS A. HARVESON**
Photos courtesy of **BORDERLANDS RESEARCH INSTITUTE**

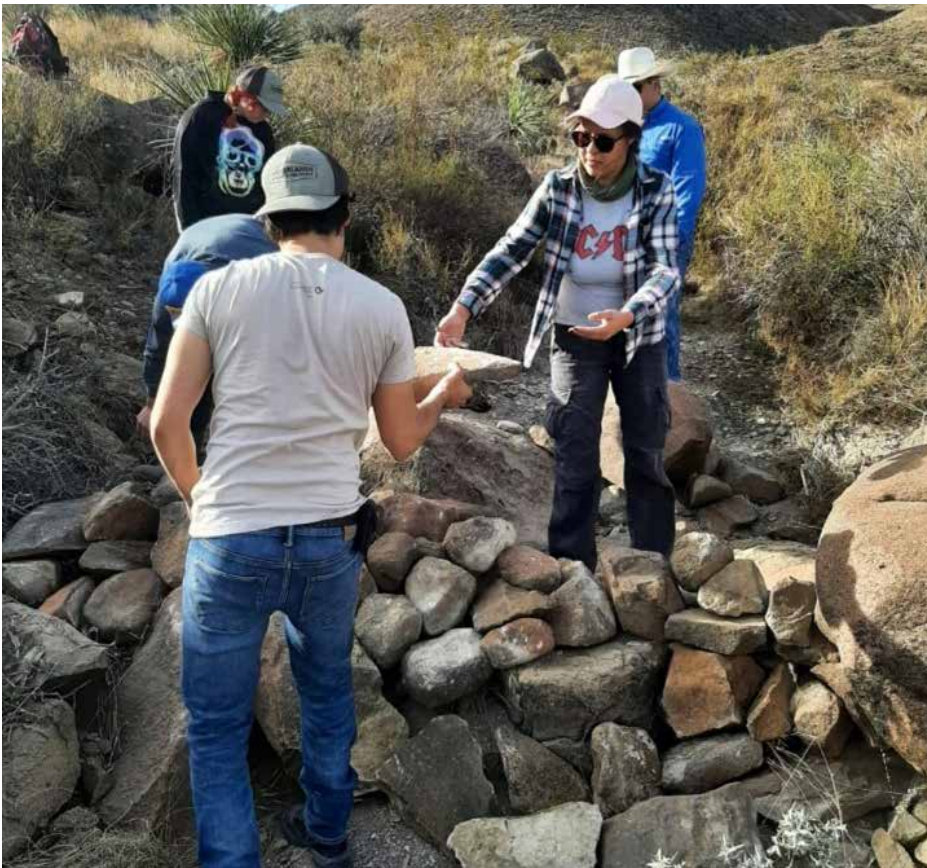
Undergrads from Sul Ross State University helped BRI researchers construct trincheras at a private property in Brewster County. Nearly 150 of these structures were set and assessed during 2022 and 2023.

To treat riparian areas, trincheras, which means rock dams in Spanish, have become popular because of their simple construction. They are constructed from materials found at the restoration site without using heavy equipment.

Construction of the 150 trincheras started upstream and went downstream. It was important to choose areas where rock was abundant, available, and easy to transport to the riparian areas. Additionally, we ensured that no material was taken from the creek's channel because those rocks were stabilizing the channel. We established the rock structures across the channel, putting

bigger rocks first and smaller ones on the outer and upper portions of the structures, reaching a height of nearly 1.5 feet.

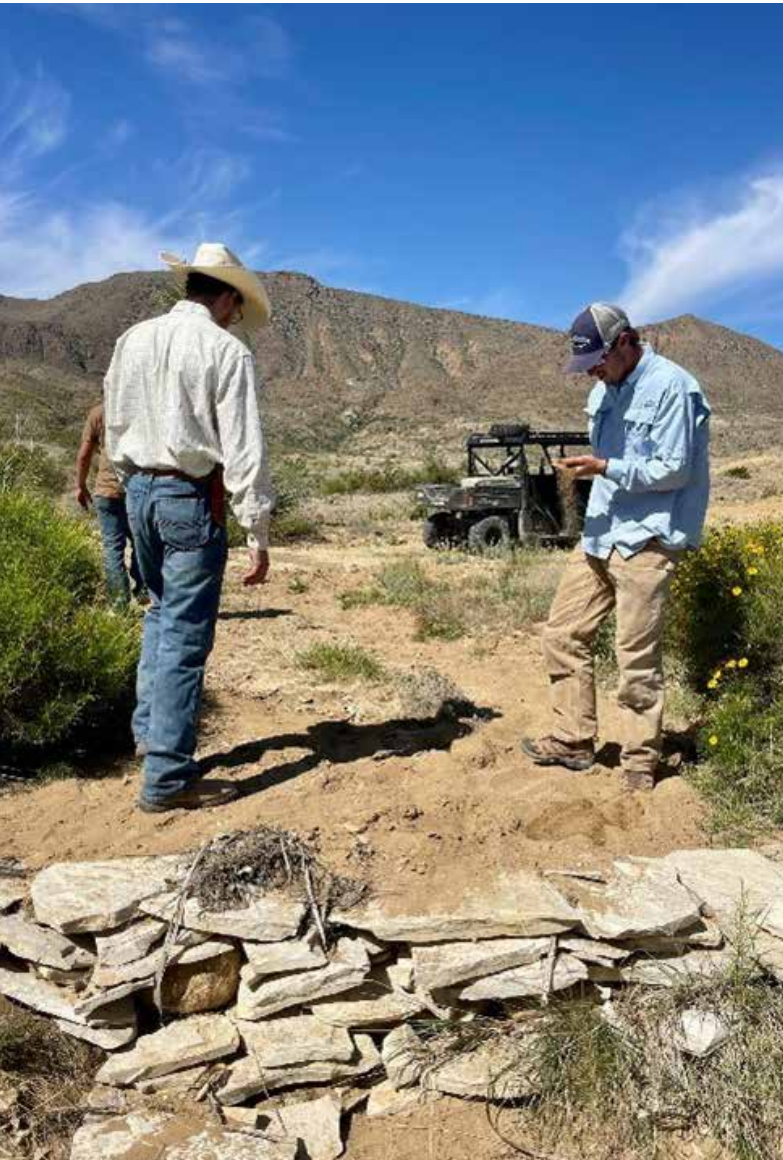
After two years, a significant amount of sediments were trapped by the trincheras. Monitoring will continue to assess plant cover changes and soil accumulation patterns.

After data were collected and analyzed, we found significant sediment accumulation at distances up to and beyond 6 feet upstream from the trincheras. At these upstream locations, average sediment accumulation was around 5 inches.

Also, we observed negligible loss of sediments downstream to a distance of 1.5 feet from the trincheras, less than 0.5

inch on average. Variability in the capture of soil sediments may be related to stream features like slope, soil type, and channel size.
